Diamond Light Source Proceedings / Volume 1 / Issue MEDSI-6 / October 2011 / e33

# Installation and diagnostics of a girder-system mockup for Taiwan Photon Source

National Synchrotron Radiation Research Center, No. 101, Hsin-Ann Road, Hsinchu 30076, Taiwan,  
Republic of China

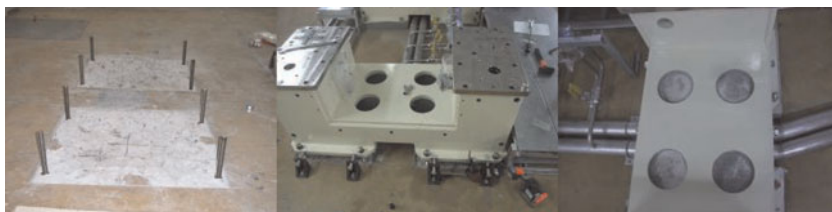
FIGURE 2. The pedestal supported by screws is aligned and grouted.

The beam direction was first set with control points that serve also to monitor the fiducial points on the girder system. After setting the centre line of each pedestal, the screws to support the pedestal were glued onto the ground with a template as in figure 2.

The positions of the nine pedestals were aligned within 0.2 mm with a laser tracker. To increase the stability of the girder, pedestals were grouted with unshrinking concrete.

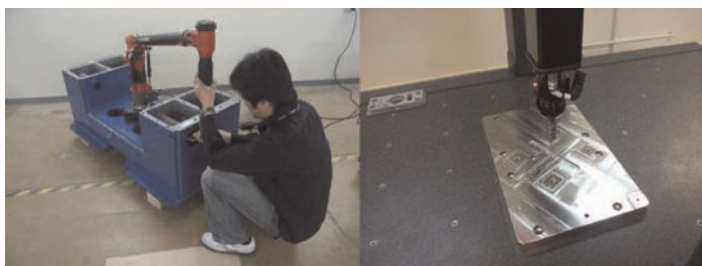
FIGURE 3. The main body and top plate of the pedestal were inspected with a CMM.

The bottom bodies and top plates of the pedestals were inspected with a portable and bridge-type Coordinate Measuring Machine (CMM) as in figure 3. The results showed that the holes on the pedestal were within the tolerance according to the engineering drawing.

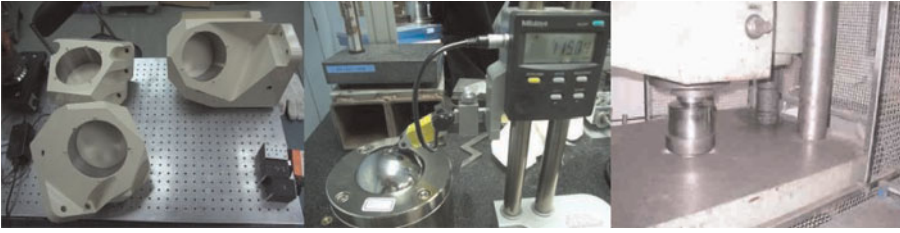
FIGURE 4. Inspecting the ball unit and housing.

Both the cylindrical outer diameter and the spherical diameter of the ball unit were inspected with a portable CMM. The height of the ball units was examined with an altimeter. The hardness (HRC) and loading test (12 tons) of the ball unit were also certified by a Taiwan Accreditation Foundation (TAF) laboratory

(figure 4). After inspection showed several ball units to be beyond specification, they were all returned to the manufacturer and replaced with new ones.
